**WATERFRONT PARK 2024-2025 WATER QUALITY  
INVESTIGATION REPORT**

**November 2025**

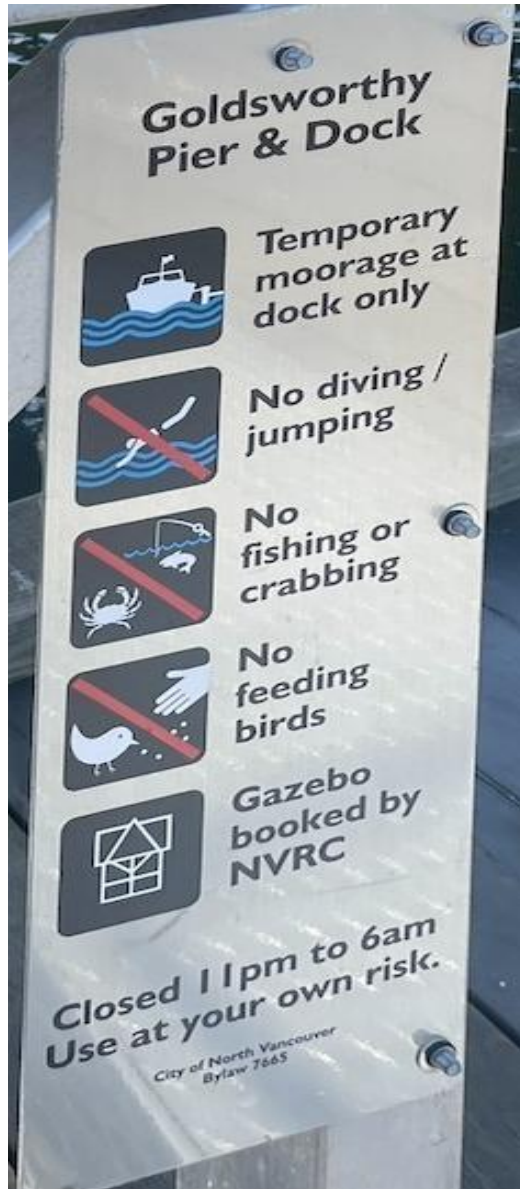
for temporary moorage (Waterfront Park, 2025). The dock provides the only official access to the water, with the rest of the park having a seawall barrier that impedes water access. In addition, the dock features signage that clearly states that the access point is “use at your own risk” and is only intended for temporary moorage; all swimming and other recreation is not permitted (Appendix A, Figure 8).

**Figure 8:** Sign at the Waterfront Park dock.

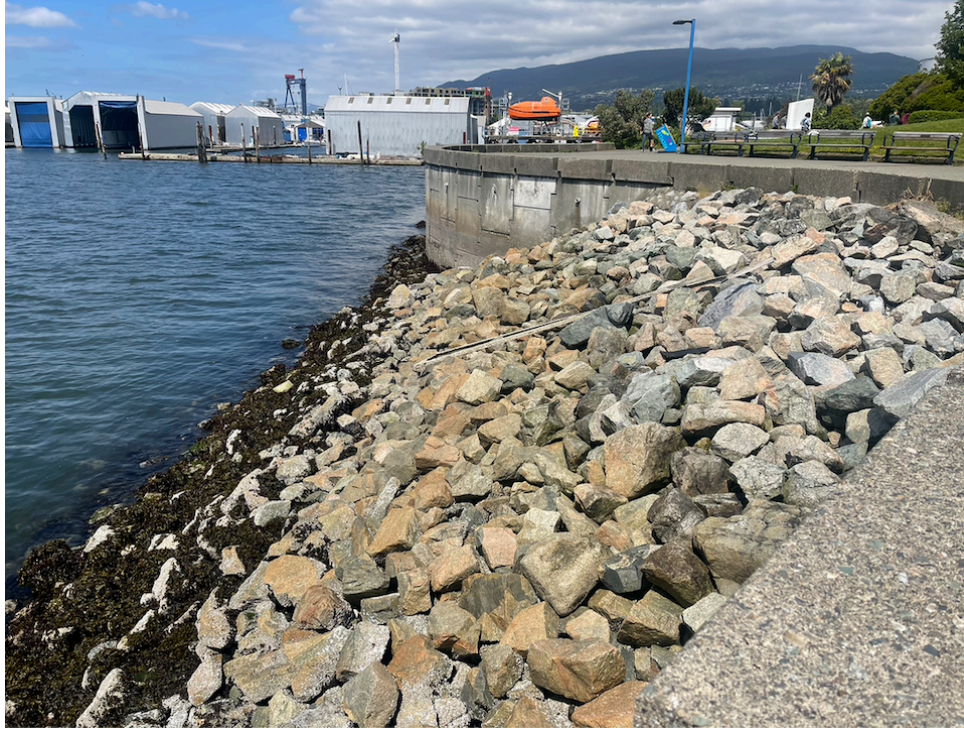
**Figure 11:** A Picture of the rocks that support the seawall shows the gradual decline towards the water surface.

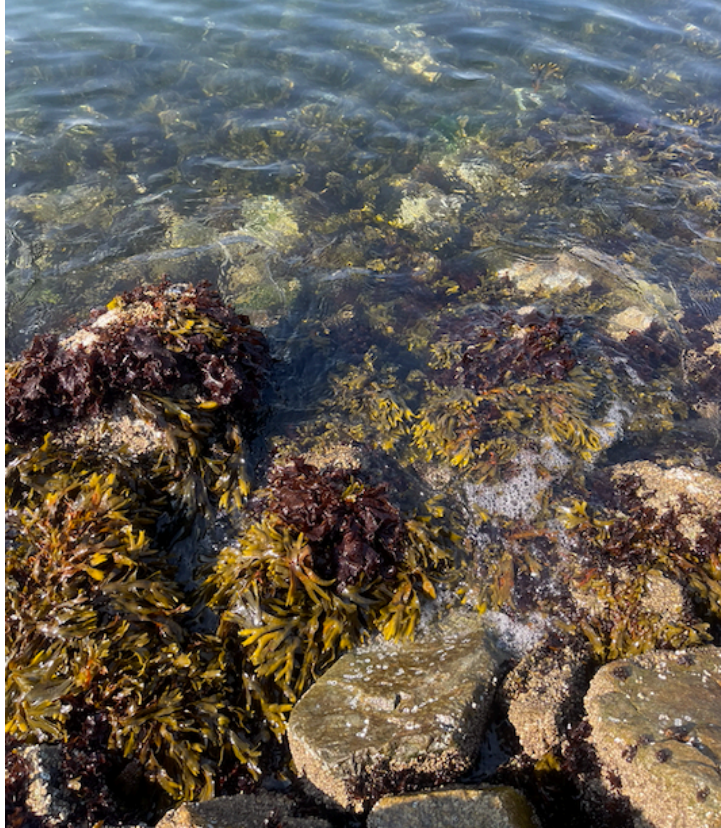
**Figure 12:** Additional photo of the rocks supporting the seawall that is submerged under water during high tide and presents with seaweed and barnacle growth.

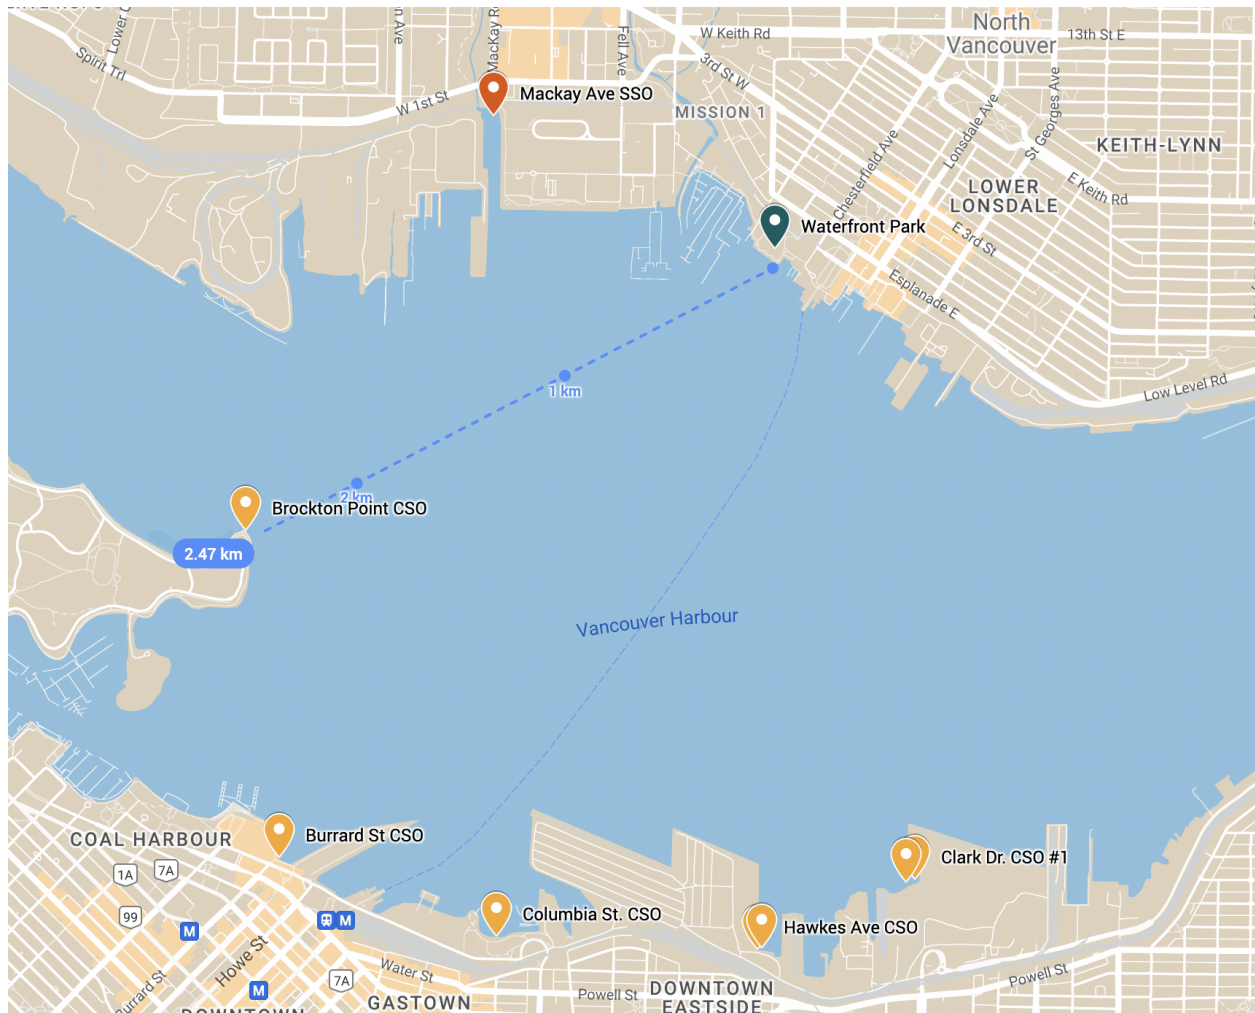
precipitation events, releasing untreated wastewater and stormwater directly into the waterbody. It can be hypothesized that any overflows occurring within the same waterbody are sufficiently distant from Waterfront Park to have no measurable impact on water quality. Attached in Appendix B is a map of all of the CSOs in the inner harbour of Burrard Inlet; the distance from Waterfront Park to the nearest CSO is drawn on the map (2.48 km).

Below is a map of the CSOs that may have an influence on the bacteriological water quality at Waterfront Park. The green pin indicates the park on this map. The Mackay Avenue pin is a dark orange to represent a sanitary sewer overflow, rather than a combined sewer overflow. The combined sewer overflows on this map are in light orange and include: Brockton Point CSO, Burrard St. CSO, Columbia St. CSO, Hawke Ave CSO, Vernon Dr CSOEHS, Clark Dr. CSO #1 and Clark Dr. CSO #2. Also demonstrated is the distance from Waterfront Park to the nearest CSO across the inlet (2.47km).
